BACKGROUND

The balconies of a condominium complex had been the source ongoing concern due to the externally apparent severity of deterioration thereof for several condominium units.

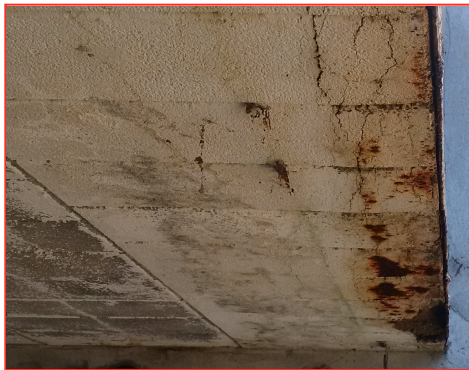
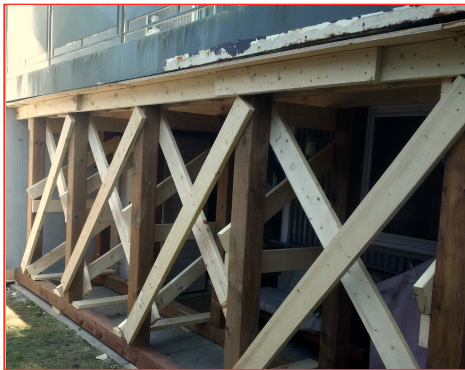
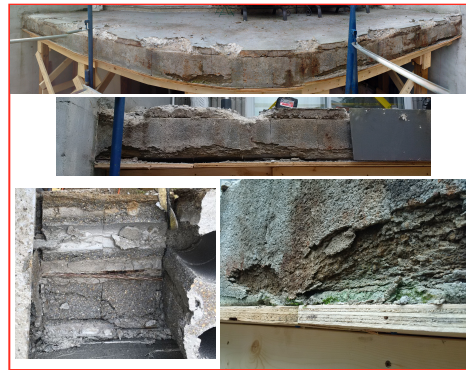
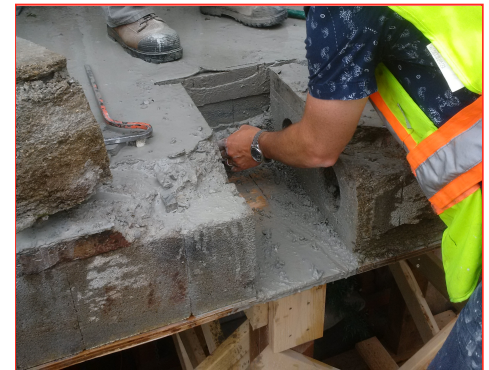
The balconies' structure included pre-stressed concrete beams supported on CMU walls between the condominium units. The externally apparent physical condition of these concrete beams varied significantly between units. Among the balconies which were suspected to be in the poorest condition; severe spalling, longitudinal cracking and steel reinforcement corrosion were observed.

The results of the evaluation suggested that the concrete beam could no longer provide the required safe load-bearing capacity. Significant portions of concrete within the beam were observed to have virtually no compressive strength; whereby some sections would collapse under their own weight during removal and smaller pieces could be crushed by hand.

It is suspected that poor weatherproofing along the edge of the beam had encouraged water to seep-in and cause increasing damage to the concrete during freeze-thaw cycles.

Induspec performed a site investigation to assess the condition of the balconies of the other units of the condominium complex. Based on the evaluation that had been completed and a visual inspection of the other balconies, the owners and the building department were notified that those balconies which were no longer safe for continued use must be rehabilitated or replaced.

A balcony restoration strategy was proposed to the owners of units with balconies that were no longer safe for use.
