## BACKGROUND

A regional hospital has two Airborne Isolation Rooms (AIR). As a normal course of business, they requested that Induspec verify air flows and differential pressure gradients in these rooms as part of an air survey.

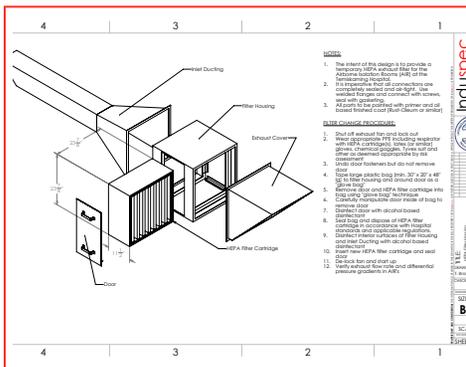
**Table 3 - Room 401 air readings (Post)**

Parameter	Value	Units
Supply Air	5.18	m <sup>3</sup> /min
Exhaust Air	9.8	m <sup>3</sup> /min
Air Exchanges	6.9	air exchanges per hour
ΔP (AIR-Ante)	-4	Pa
ΔP (Ante - Hallway)	-1	Pa

**Table 4 - Room 402 air readings (Post)**

Parameter	Value	Units
Supply Air	4.9	m <sup>3</sup> /min
Exhaust Air	8.8	m <sup>3</sup> /min
Air Exchanges	6.6	air exchanges per hour
ΔP (AIR-Ante)	-4	Pa
ΔP (Ante - Hallway)	-1	Pa

With the implemented changes, although the overall pressure gradient is still 1% less than required, the gradient is operating in the right direction so that air is always pulled through the ante room, through the patient room and out via the dedicated exhaust.

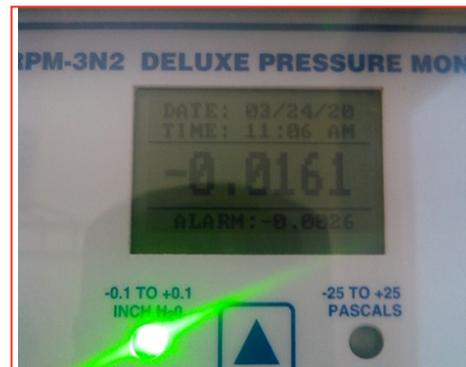
**401 Negative Pressure Room**  
Room Name

Parameter	STANDARD	RESULTS
Temperature (°C)	22 - 24	23.1
Pressure (kPa)	None	98.627
Relative Humidity (%)	30 - 60	23
CO (PPM)	< 1,000 PPM	485
Exhaust	Def	
Air Changes per Hour	12	4.5
Relative Pressurization	Neg	Pos
Burnance (lux)

Room 8 exhausting at 0.61  
Bathroom is an additional 10.71 m<sup>3</sup> (included in total)  
hallway at 58.55 fpa
